# **Sandy Gulch (Lindo Channel) Resource Inventory**

***July 2001***

# **SANDY GULCH RESOURCE INVENTORY**

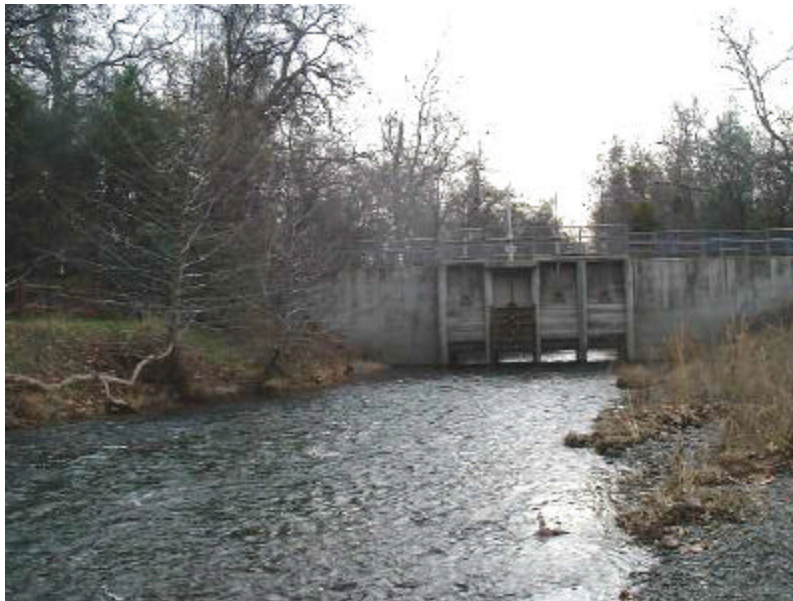
*Photo 1.1: Box culverts regulating flow on Big Chico Creek into Sandy Gulch.*

that regulate flow on Big Chico Creek and pass water into Sandy Gulch (see **Photo 1.1**).

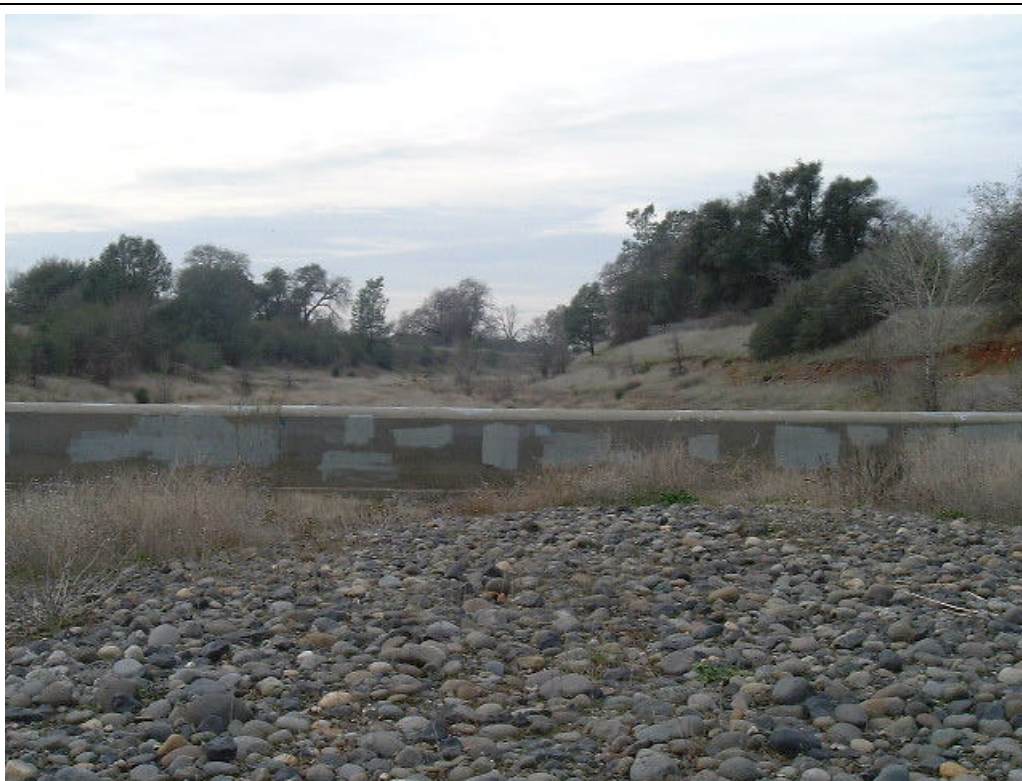
*Photo 1.2: Concrete weir controlling flow into the Sycamore Creek Diversion Channel*

A nearby concrete weir controls flow into the Sycamore Creek Diversion Channel (see **Photo 1.2**). During high flows, water may overtop the weir and flow north in the diversion channel to the “south branch” of Sycamore Creek. During summer months, there is little or no flow in Sandy Gulch. In addition to overflow from Big Chico Creek, Sandy Gulch conveys runoff from

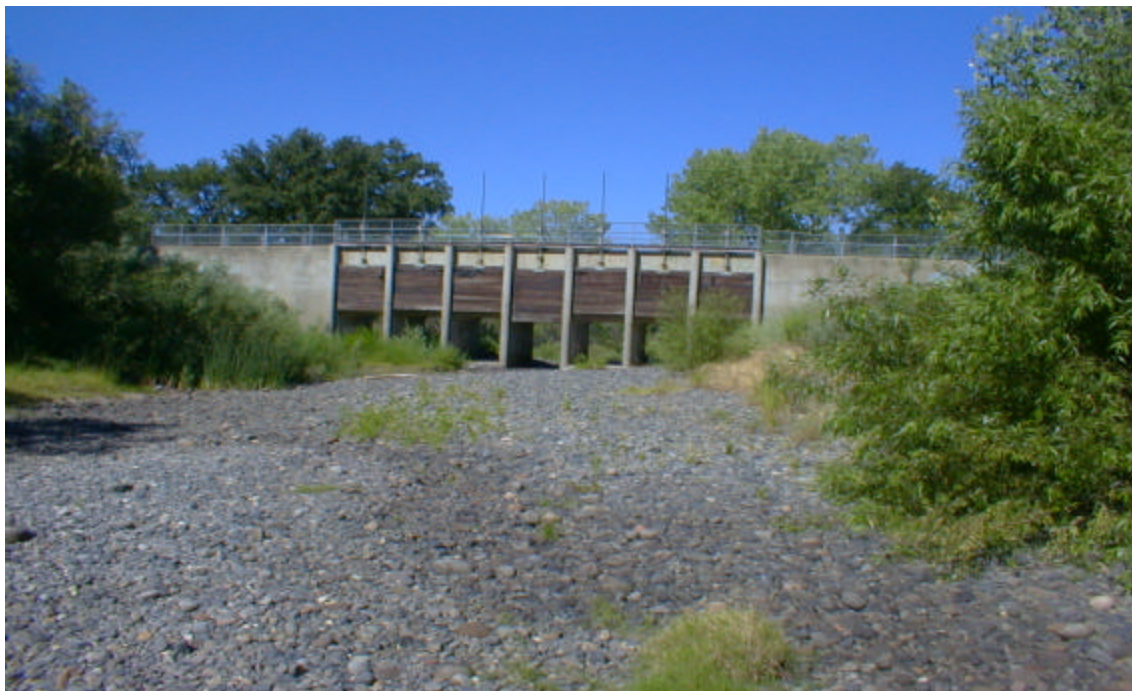
*Photo 1.3: Lindo Channel Dam at the Head of Sandy Gulch*

Based on flow records from the DWR gage on Bidwell Avenue, which date back to 1956, Hydro Science concluded that some type of flood control was practiced on Big Chico Creek prior to the installation of the current flood control improvements in the mid-1960s (Hydro Science, 1999). It is important to note, however, that the installation of the high flow by-pass from Big Chico Creek-Sandy Gulch into Sycamore/Mud Creek has essentially “capped” the flows that can enter Sandy Gulch. Flows in excess of 1,500 cfs are diverted into Sandy Gulch. There are gates that limit inflows to ensure capacity is available for urban runoff (see **Photo 1.3**).

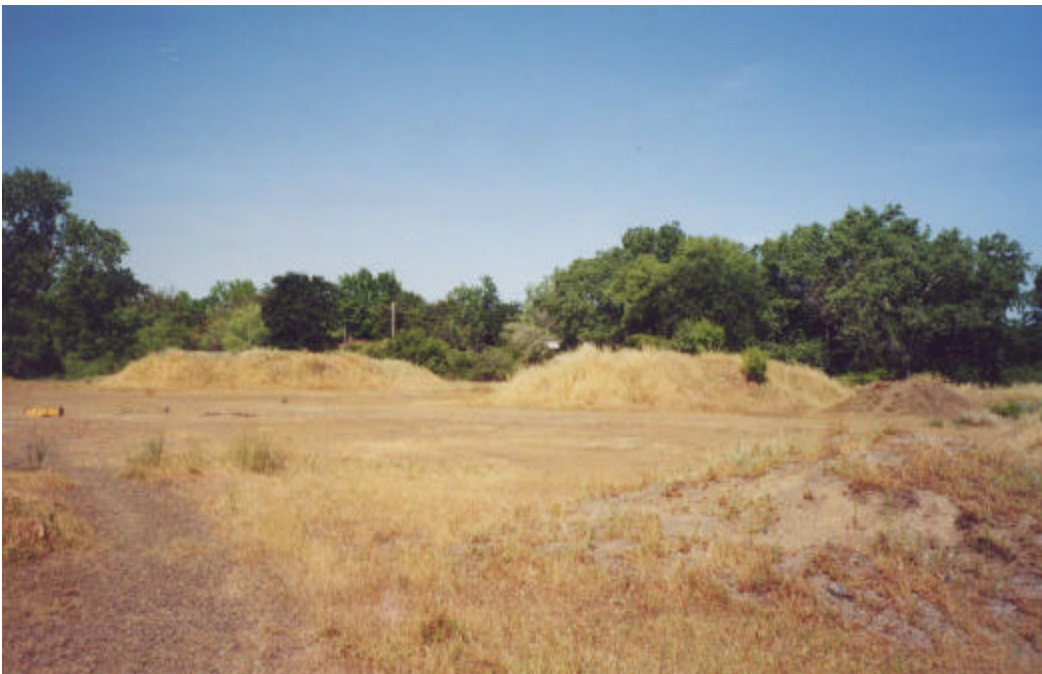
*Photo 2.1: Butte County's old aggregate stockpile.*

According to Public Works personnel field notes, Butte County sustained some form of gravel extraction on Sandy Gulch from the early 1960s to the mid-1980s. The quantity of extraction is not clearly documented. Although, stockpiles were measured yearly, additions to and extractions from the stockpile during the year were not catalogued. According to discussions with past Public Works’ field crew members, the County would truck out crushed rock from the stockpile, which is still visible, just upstream from Longfellow for shoulder work, filling mud holes, and minor roadwork (see **Photo 2.1**). The County rock-crushing unit would visit the site

approximately every 10 years or as needed, in order to maintain a stockpile mound approximately 20 feet high and 200 feet long. The main supply area was called the “Ceanothus Pit” as it was located in Sandy Gulch adjacent to where Ceanothus Street is perpendicular with Sandy Gulch (see **Figure 2.3**). An additional stockpile was kept just downstream of Madrone Avenue on the southern side of the stream.

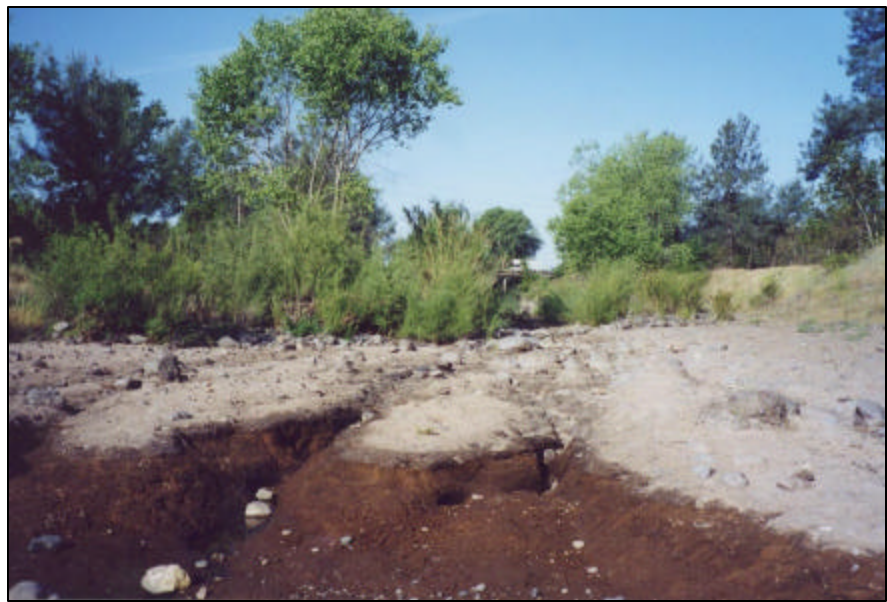
*Photo 3.1: Tuscan Formation in Sandy Gulch upstream of the Manzanita Avenue Bridge*

formation, and perhaps remnants of other consolidated deposits of different origin, can be present in the bed or banks of the stream (see **Photo 3.1**).

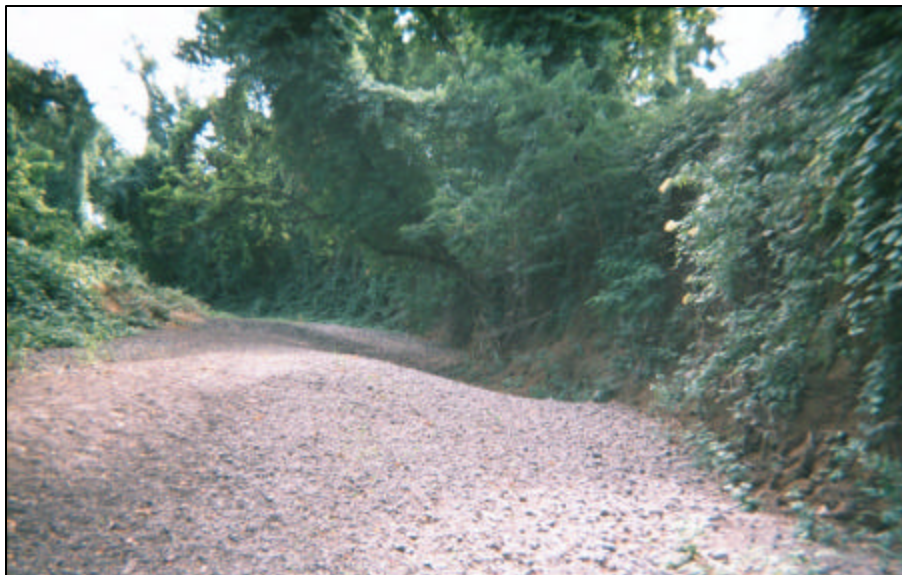
*Photo 3.2: Deep-rooted riparian vegetation along lower Sandy Gulch.*

Although the channel banks themselves typically lack erosion resistant cobbles and are more uniformly sandy in texture, these attributes, unlike Sandy Gulch's upper reach, allow deep-rooted woody vegetation to flourish (see **Photo 3.2**). This relatively dense cover of riparian vegetation stabilizes the banks through the influence of roots and through physical protection of the banks by stems, limbs, exposed roots, and the trunks of trees (Hydro Science, 1999). The bank materials in some locations also have a large enough percentage of clay to add some cohesive strength to the banks. Overall, however, it is the existence of the dense riparian vegetation, which maintains the high steep banks and allows the existing entrenchment to persist.

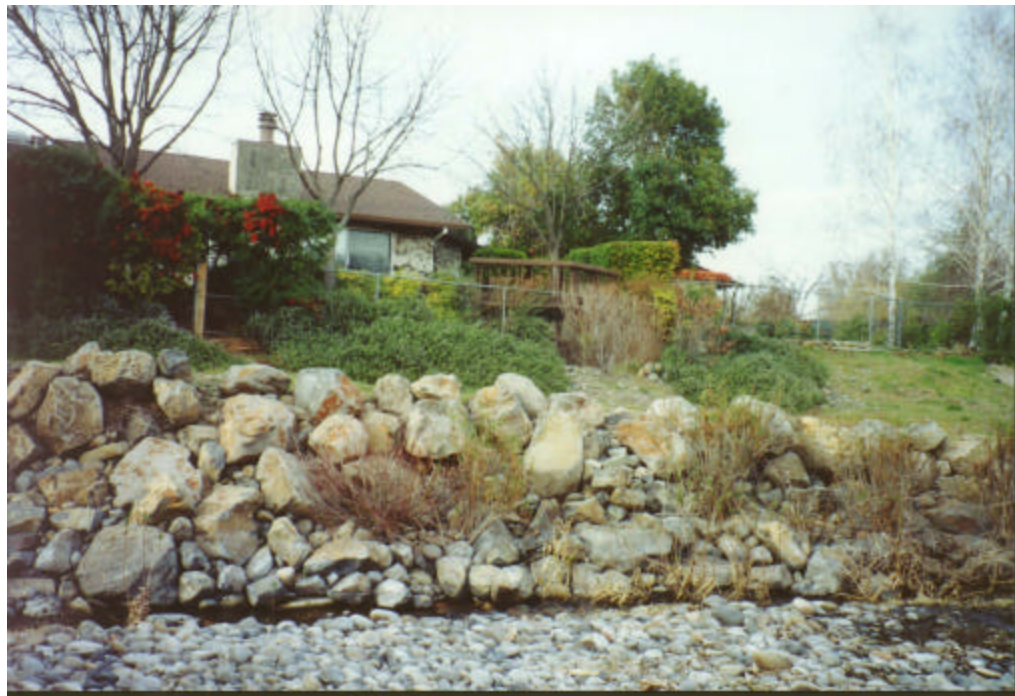
*Photo 3.3: Rip-rap in place as bank protection measure.*

protect structures and property (see **Photo 3.3**). It is unclear why the stream channel shifted so significantly in this stretch. Possible scenarios include: 1) during high flows the stream either denuded or jumped the bank and reclaimed an historic channel, or 2) the old channel (which matches the Bidwell-deeded area) was filled and flows redirected, and therefore either a concerted public or private effort was undertaken to shift Sandy Gulch's channel, perhaps for flood control concerns. Other possible explanations include, reduced rates of bed load sediment supply, a decrease in flood peaks and sediment transport capacity, or possibly prolonged bankfull flows. There is a significant remnant riparian forest where the channel historically flowed (see **Photo 3.4**). The area is currently an upland zone adjacent to existing homes used as open space.

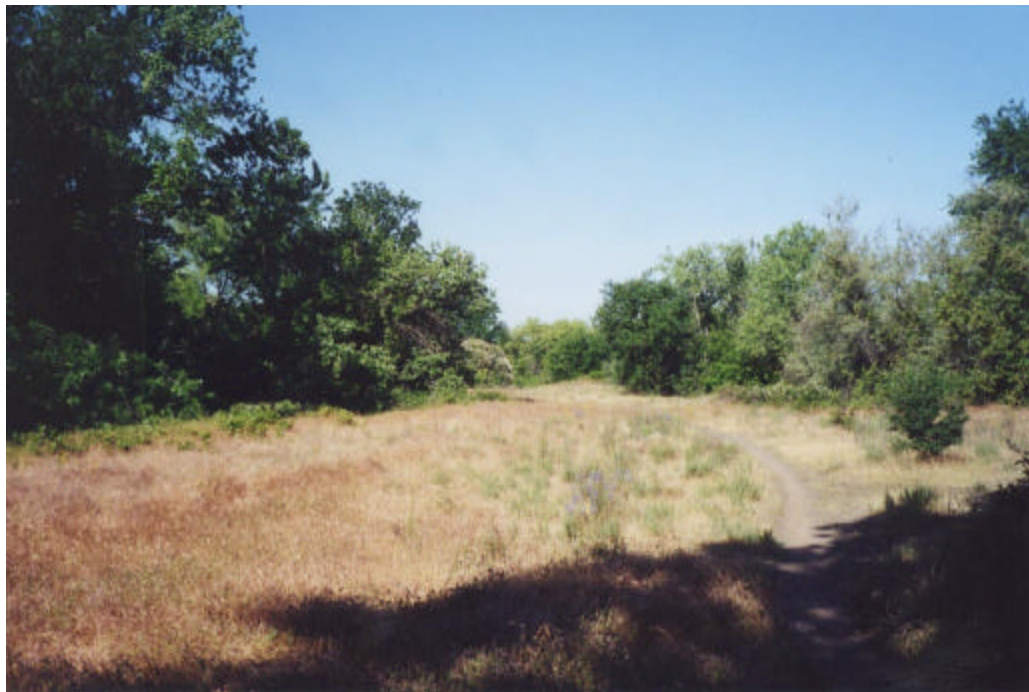
*Photo 3.4: Remnant riparian forest where channel historically flowed*

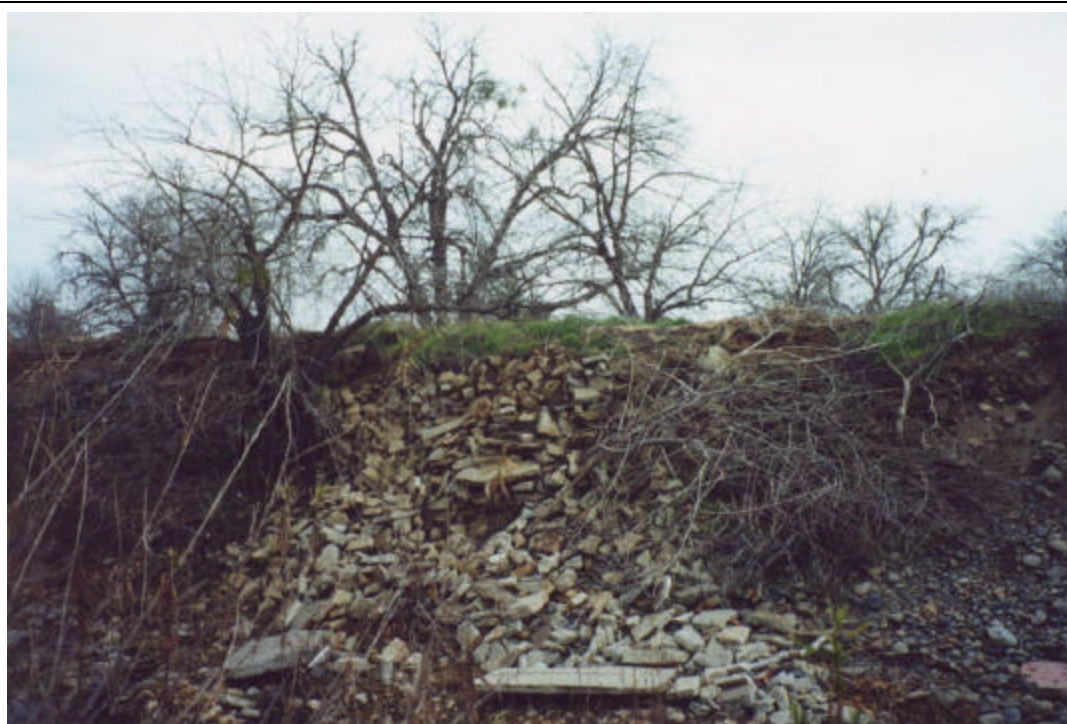
*Photo 3.5: Example of informal bank protection measures.*

Instances of localized bank erosion have increased formal and informal efforts to maintain and enhance bank stability. Even when bank erosion results from natural stream processes, resources (i.e., property, structures) threatened by erosion or flooding have created the demand for bank protection measures. The majority of bank protection measures on Sandy Gulch are considered hard, or “engineered.” This includes placement of gabion baskets, riprap, masonry walls, concrete walls, and boulder walls along the channel toe or banks. In addition, there are many informal bank protection efforts, which utilize material such as concrete rubble or yard waste (see **Photo 3.5**). Bank armoring measures are predominantly located at bridge crossings and at the outside of meander bends where structures and property are at risk. Based on field surveys, local bank protection measures along Sandy Gulch within the Study Area have been identified and added to the GIS (see **Figure 3.5**).
